Careyville Wells

**REPORT
ON TESTING
& EVALUATION
OF OLD
SOLUTION
MINING WELLS**

August 28, 2009
Geological Evaluation for VIG Industries
Former Carey Salt Company Solution Mining Wellfield, Hutchinson, Kansas

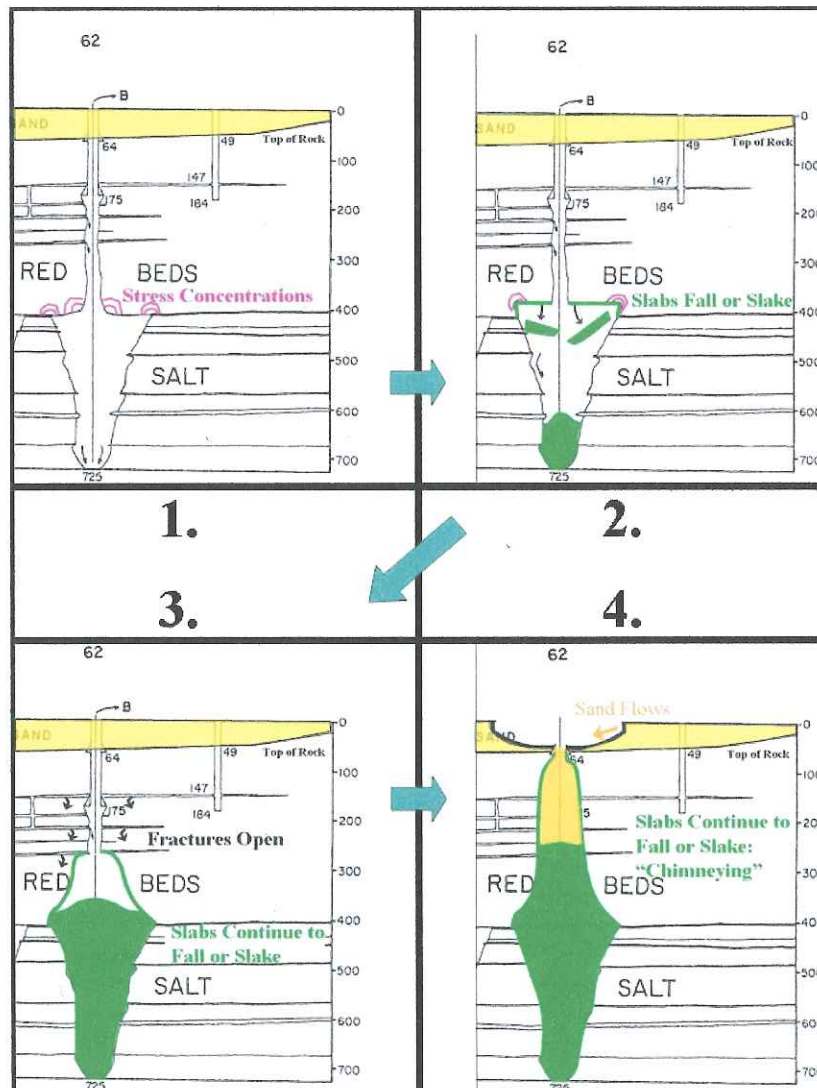
Sketch 1. Crater formation at the surface is the result of flowage of loose sand at the surface into the cavern via a collapsed shale roof beam.

- If collapse of a cavern occurs, it may form a crater rapidly and possibly with few or no advance warning symptoms at the surface. Conversely, in some occurrences, there may be little or no surface expression of a cavern collapse due to the bulking of materials as they fill the subsurface void.

- Surface crater formation is due to the flowage of the near-surface sands (which overlie the bedrock to depths of approximately 60 feet) into the salt cavern void upon collapse of the shale bedrock roof beam over the cavern, as shown in attached Sketch 1.

Progression of a collapse is: (1) Buildup of stress in the shale bedrock roof beam; (2) and (3) Gradual or sudden, progressive falling of the cavern's shale roof beam, that: (4) Allows the near surface, largely saturated, loose sands to flow down into the cavern void, creating a crater at the surface. The crater diameter is dictated by the size of the cavern void: Large void = big crater; Small void = small crater.

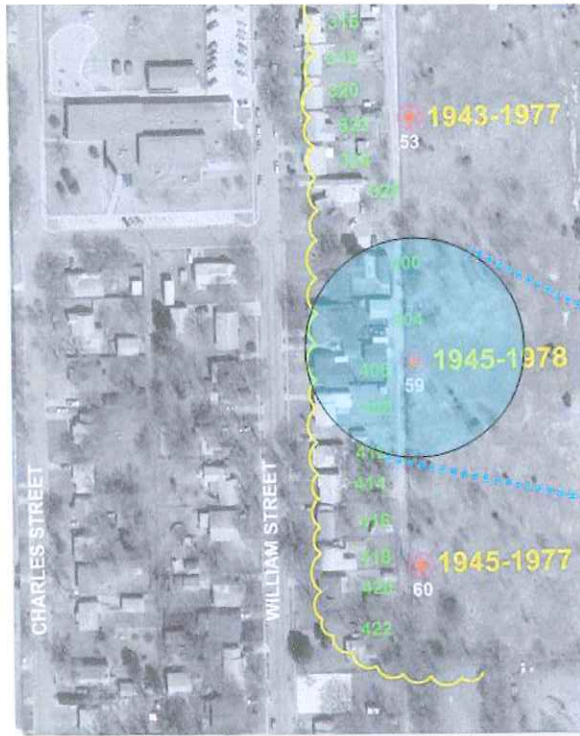
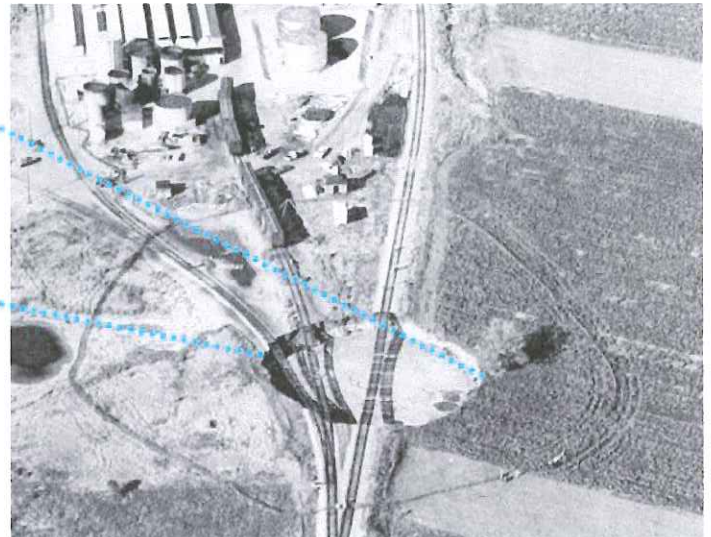
Sketch 2. Establishing KDHE Approved "Safe Zone" Boundary as Worst Case Crater in Kansas

- A conservative "safe zone" line approved by KDHE is defined by the radius of the largest salt mine sink in Kansas history, as shown in attached Sketch 2.

"Safe Zone" boundary (yellow line), as approved by KDHE, was defined by superimposing the radius (160 to 180 feet) of the largest salt well sink in Kansas history (1974, in southwestern Hutch) onto the wellheads of the former Carey salt wells along William Street and Carey Blvd, assuming these wells were ever to collapse.

This represents a conservative approach to protection of human health and safety because any sinks that might form if the Carey well caverns were to collapse would likely be smaller than the 1974 collapse, because it was in a huge gallery of multiple wells when it fell, while the salt tonnage records for the Carey wells indicate relatively small caverns. Since the salt tonnage records are a bit uncertain as to accuracy and completeness, a safe approach was to assume the worst case known scenario.
